# **Experimental Fire Tests of Two-Way Concrete Slabs**

**University of Canterbury  
Fire Engineering Research Report 02/12**

**September 2002**

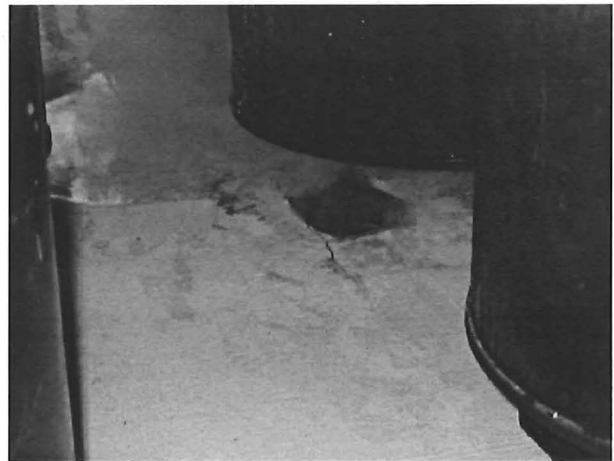
At about 1 hour and 25 minutes, the puddle level in the middle of the slab started to reside. There were no cracks visible on the bottom surface of the slab, seen through the viewing ports located on the east side of the furnace. At 2 hours 15 minutes, the corners of the slabs had lifted up to 119mm and the puddle of water in the middle of the slab had dried up. The first set of cracks which appeared on the unheated surface (running down the centre of the slab) had opened up to 5mm wide without flames passing through these cracks.

**Figure 6-3: Water puddle in the middle of the slab.**

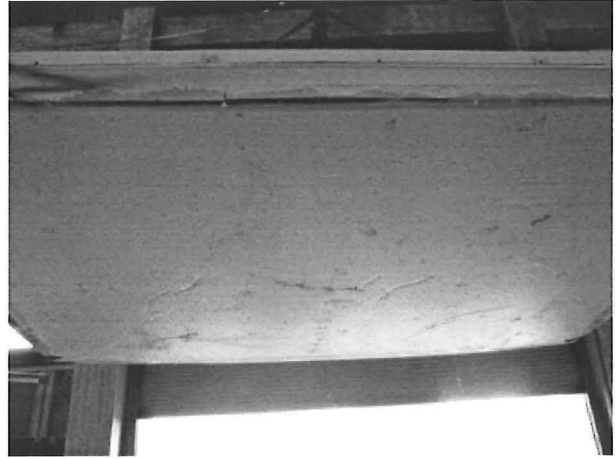
The bottom surface of the slab was very smooth and did not show any signs of cracking or spalling. The line indentations on the bottom surface of the slab were due to creases in the polyethylene sheets when the slab was cast and not due to the effects of the fire (Figure 6-5). The most visible cracks on the top surface were in the middle of the slab, running in the

**Figure 6-5: Underside of the slab after the fire test.**

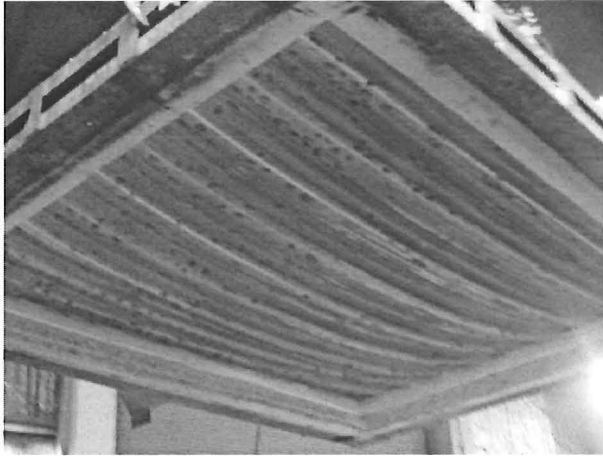
As 3 hours approached, large longitudinal cracks had formed at the top surface, 200mm from the edges, running parallel to the long sides of the slab. The initial crack (due to mishandling) had widened significantly and at 3 hours, flames started to penetrate this crack. When the slab was lifted off the furnace, the steel decking was glowing pink, with severe blistering on the decking surface (Figure 6-36).

**Figure 6-36: Hibond slab being lifted off the furnace.      Figure 6-37: Deflected slab after the fire test.**

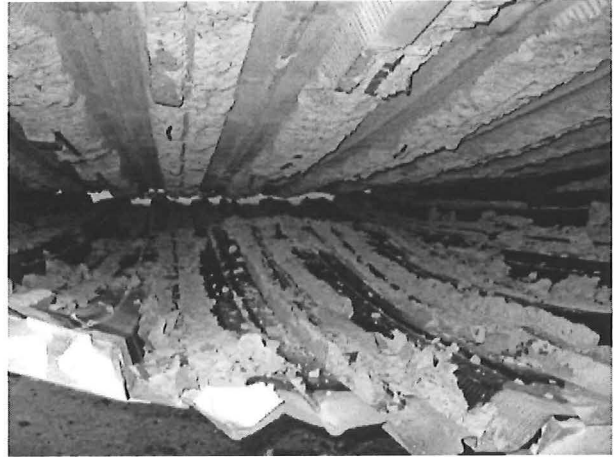
Figure 6-39 shows that the centre region of the sides of the slab had deflected inwards, relative to the corners of the slabs. The large midspan deflections had caused the centre regions of the sides to contract and deflect inwards. Figure 6-40 shows a large amount of concrete had spalled off the ribs of the slab when the steel decking was pried from the slab. The steel decking held the concrete in place, preventing it from falling off the slab and exposing the reinforcing steel.

**Figure 6-40: Bottom of the Hibond slab after the steel decking was pried from the slab.**

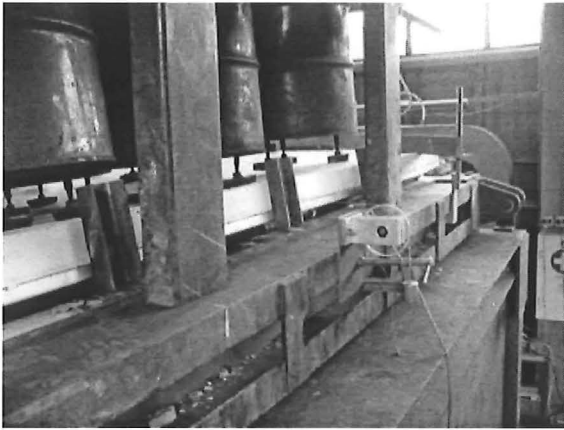
**Appendix Fig. 72: Tilting of the drums due to the large deflections of the slab during the test.**

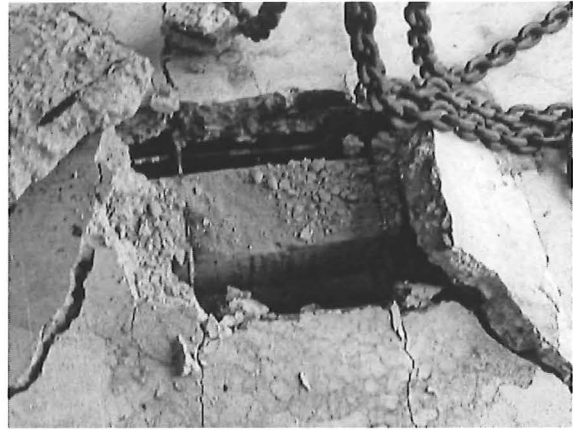
**Appendix Fig. 73: View of the demolished slab showing the unfractured reinforcing at midspan.**

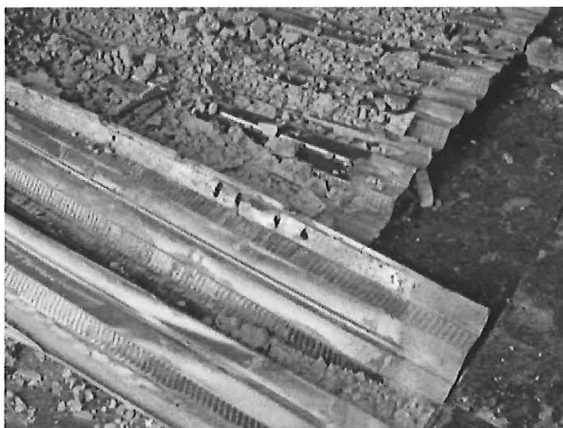
**Appendix Fig. 81: Holes in the steel decking due to oxidization.**

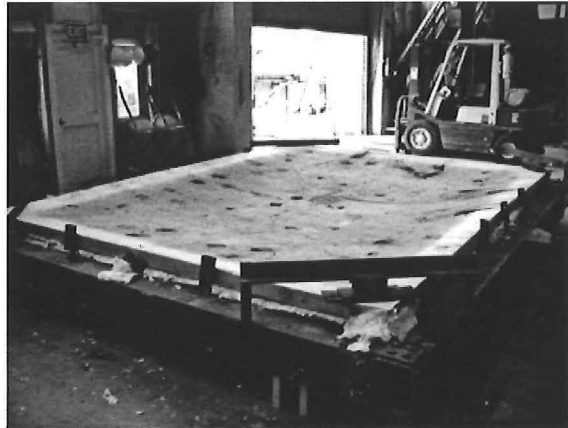
**Appendix Fig. 85:** Deformed shape of the slab after the test.
